Manhole Inspection Summary

Manhole # S39S__023MH

Insp Date: **10/13/08 1:09 PM**

Location Address: **webster st.**

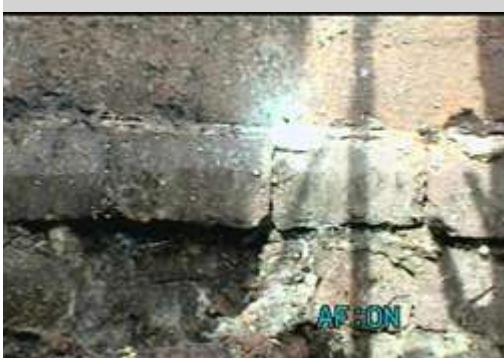
Defect 3

Condition: ☐ Sound ☒ **Cracked** ☐ Root Intrusion ☐ Loose Brick ☒ **Deteriorated**

chimney cracked & deteriorated

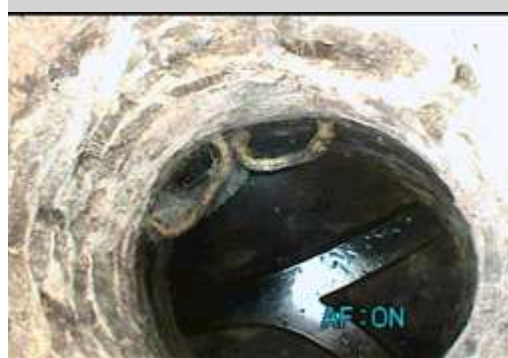
Defect 2

Count: **4** Missing: **0** ☒ **Corroded**

cor. steps

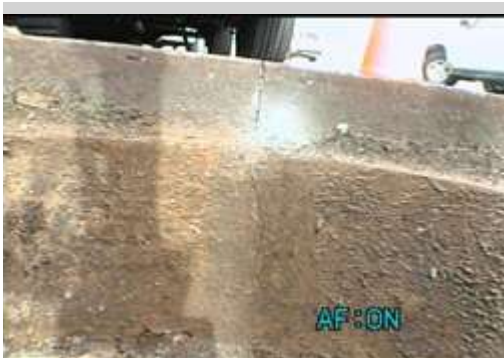
Defect 1

Condition: ☐ Sound ☒ **Cracked** ☐ Leaks

cracked frame

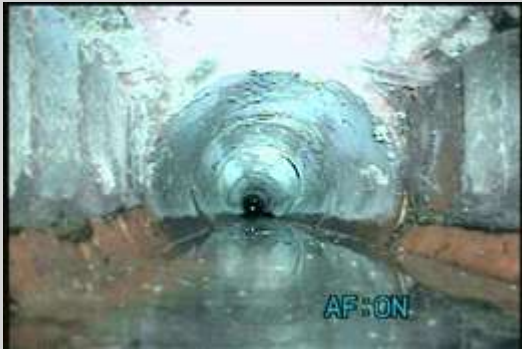
12 O'Clock Outflow

8 in. Circular Gravity Sewer
Pipe Out @ 12 O'Clock

Deposits: ☒ None ☐ Mud ☐ Sludge ☐ Debris ☐ Grease

Infiltration: **None** Pipe Seal Cond: **Unknown**

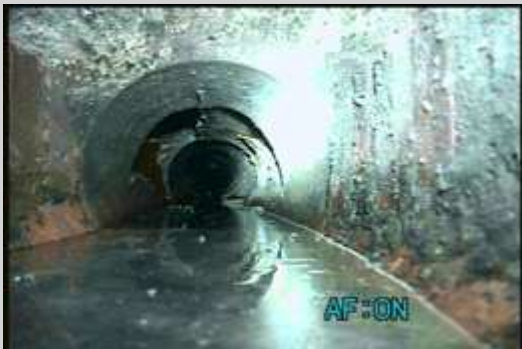
6 O'Clock Inflow

6 in. Circular Gravity Sewer
Pipe In @ 6 O'Clock

Deposits: ☒ None ☐ Mud ☐ Sludge ☐ Debris ☐ Grease

Infiltration: **None** Pipe Seal Cond: **Unknown**

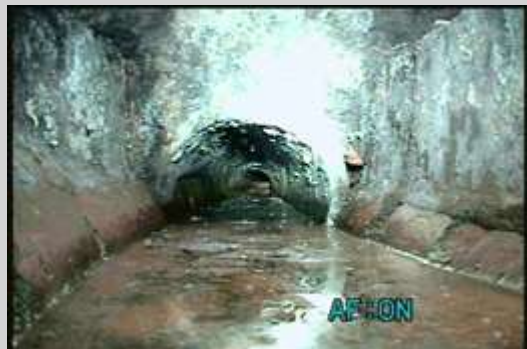
9 O'Clock Inflow

8 in. Circular Gravity Sewer
Pipe In @ 9 O'Clock

Deposits: ☒ None ☐ Mud ☐ Sludge ☐ Debris ☐ Grease

Infiltration: None
